# WOODSIDE JUVENILE REHABILITATION FACILITY

An overview of the existing facility, building and program shortcomings, and an introduction to the proposed 30 bed replacement facility.

February 2017

WOODSIDE JUVENILE  
REHABILITATION CENTER  
ESSEX, VERMONT

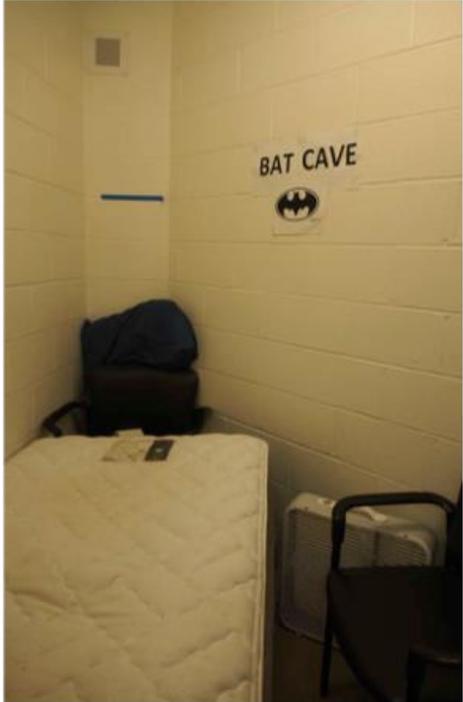
EXISTING STAFF SLEEPING ROOM

- Staff space needs to be outside the secure zone so they can access personal items and use phones or computers not allowed in the secure area.
- Staff doing 59 hr. shifts do not have sleeping, bath or personal space and what does exist is not isolated from ongoing noise or movement. One infamous staff sleeping space is known as the Batcave. It is a storage closet not really large enough for a mattress off a series of interconnected program space rooms.

- For staff sleeping at night, going to the bathroom can become a journey through multiple locked doors which interrupts sleep cycle.
- The staff sleeping spaces, often closets, are within the secure zone which means they can't use their cell phones or computers to communicate with family.

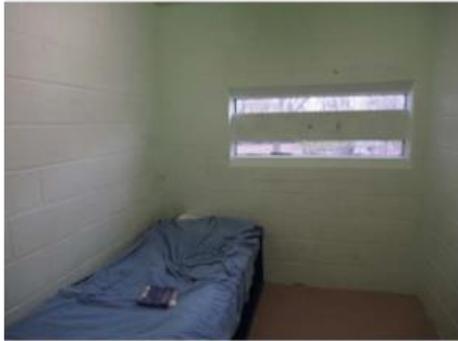
EXISTING RESIDENT SLEEPING ROOM

- Resident rooms feel like jail cells.
- Resident room doors swing in instead of out hindering access and safety. This is dangerous for both staff and youth if the staff needs to get a door open.
- Resident rooms have too many unsafe aspects including ligature points (defined as something that can be used to hang from). Rooms provide access to lighting and other elements which can be damaged or weaponized.
- Portions of common space and bathrooms also create unsafe conditions.

- Windows and doors in sleeping rooms need to be replaced - BGS estimated cost of \$150k
- Sleeping areas for staff need to be provided / renovated - BGS estimated cost of \$75.
- Update entrance vestibule - BGS estimated cost of \$5k
- Entrance to maintenance shop not adequate (need more space) maintenance shop should be separated from facility with sufficient workspace.
- Doors and locks in units not rated for the abuse.
- BGS staff needs a clerical office.
- Not enough custodial closets, floor sinks, or storage space. We need storage for custodial machines and supplies.
- Woodside staff needs a floor sink and closet for custodial services carried out by Woodside staff and possibly training to residents.

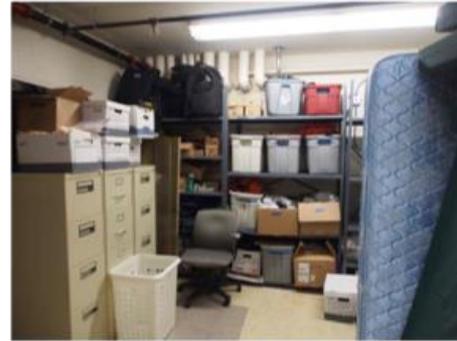
EXISTING STORAGE ROOM

- There is insufficient storage throughout.
- There is insufficient space for maintenance, housekeeping and BGS personnel and it doesn't have a direct connection to common space or exterior. You need to go through the boiler room and dining/dishwashing/kitchen.

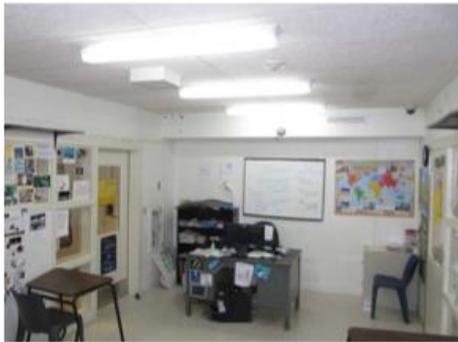
EXISTING CLASSROOM

- The classroom layout does not work and there are insufficient spaces for critical program elements such as libraries, computers, art, music. The classrooms are spread on two floors and intermixed with other functions which makes it difficult for the residents to feel that they are leaving the unit and 'going to school' for the day.

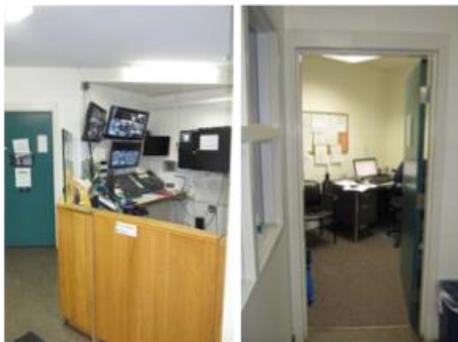
EXISTING CONTROL ROOM

- There is insufficient administrative space, only a small conference room and no space for ongoing training of staff.
- Central control is open to the entry lobby. This compromises security and creates distractions for the control personnel.

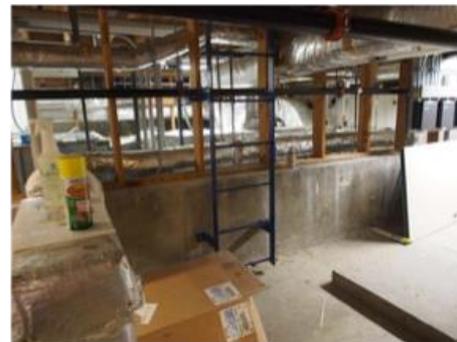
EXISTING MECHANICAL LOFT

- Attic spaces too small to service equipment.
- Smoke detectors in cells damage easily.
- Strobes and horn in bathrooms damage easily.
- Not enough isolation valves in plumbing system.
- Current bathroom surfaces and venting are not adequate.
- Plumbing access panels for service are inadequate.
- Dampers for supply air for boilers have had issues.
- Protected lighting in blue and green areas easily damaged.
- Facility bathrooms need additional venting and surfaces must be durable for this type of facility.
